**Industrial Consultancy Services**  
**on**  
**Energy Audit, Power Quality, Energy Conservation,**  
**Thermography based Audits and**  
**Energy Management**

**Submitted by**  
**SRI ESHWAR COLLEGE OF ENGINEERING**  
**SRI ESHWAR ENERGY DIVISION (SEED)**

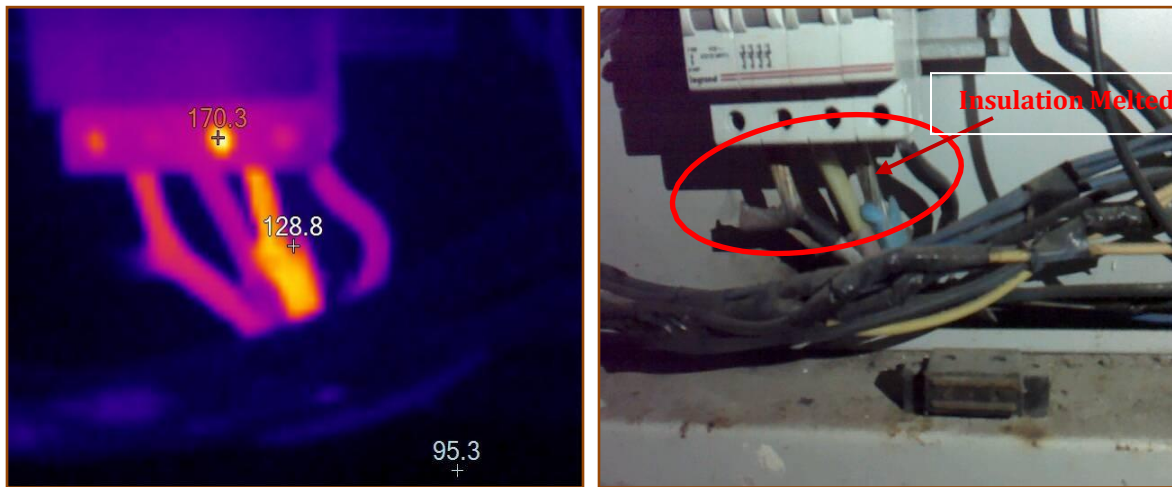
1. It is observed that, excessive temperature rise (170.3°F) in one phase (it may be B-phase) of incoming section of the distribution panel located back side of the guest room.

**Thermography Image on in DB (Located back side of the guest room)**

| Problem Observed | Excessive temperature rise in one phase (it may be B-phase) of incoming section |
| Cause for the Problem | High current/improper sizing of conductor/Corrosion/loose connection |
| Effect of the Problem | Melting due to high temperature and supply interruption |
| Down Time | Minimum of 1-2 hour |

| Recommendation | Problem must be immediately addressed |

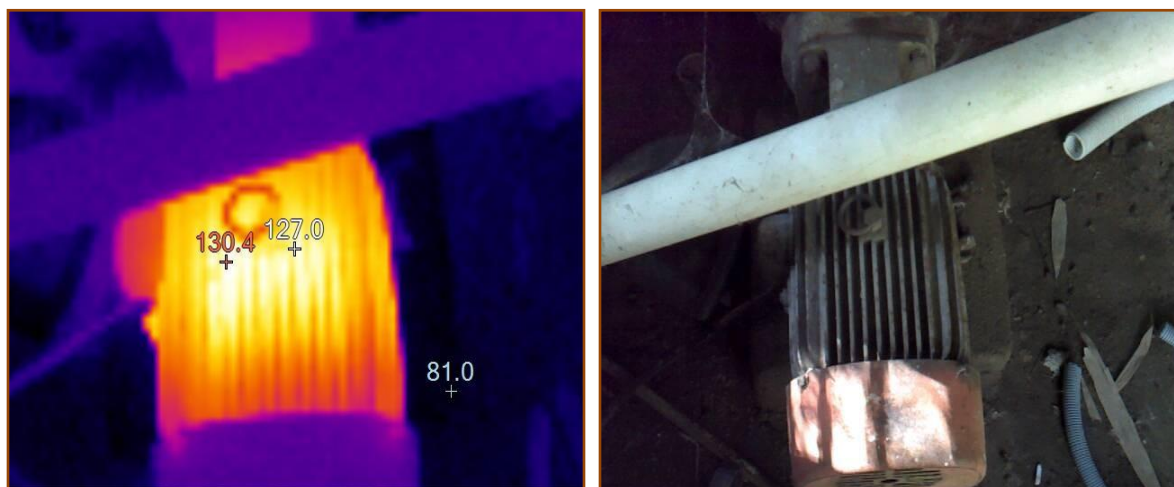
2. In the same motor excessive temperature rise (ranging from 122.0°F to 130.4 °F) is found in the motor body. Hence it is recommended to completely check the motor and rectify the faults identified.

**Thermography Image on swimming pool pump motor (Motor Body)**

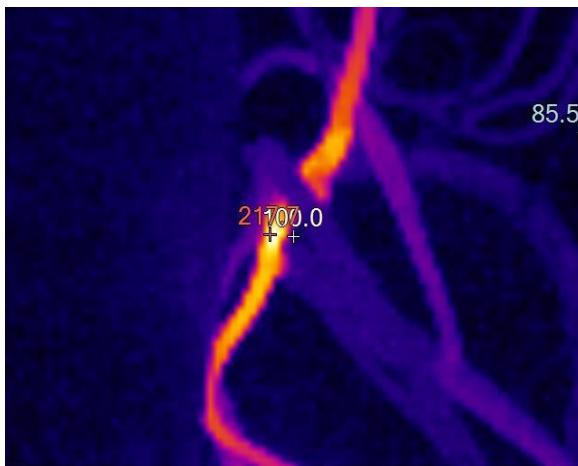
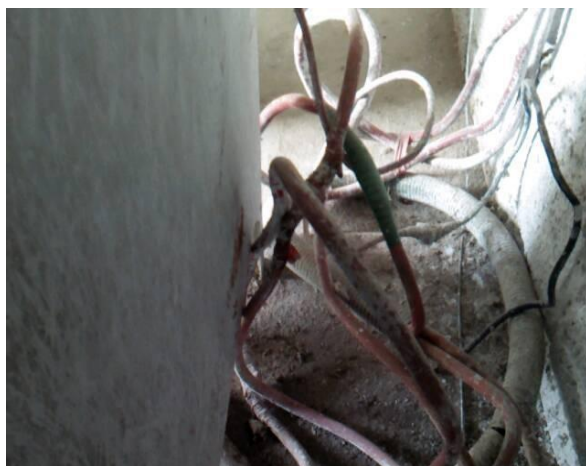
**Thermography Image on EB-Main Incoming (Backside)**

| Problem Observed | Excessive temperature rise in backside of EB main incoming – Cable joint |
| Cause for the Problem | Weak joint/ Loose connection |
| Effect of the Problem | Melting due to high temperature and supply interruption |
| Down Time | 1-2 hour (minimum) production loss |

| Recommendation | <ul style="list-style-type: none"> <li>• Problem must be quickly addressed during monthly maintenance time</li> <li>• Recommended to root the wires properly with sufficient panel board</li> </ul> |

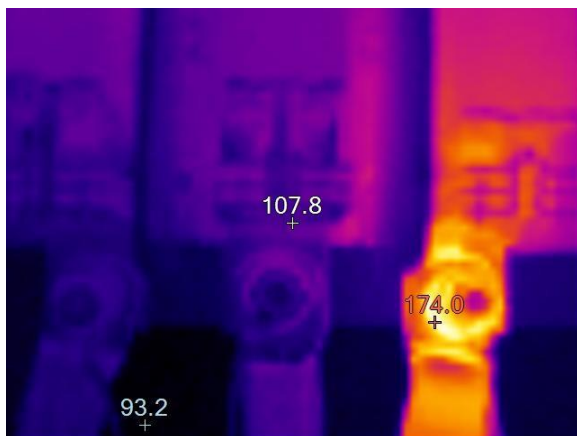
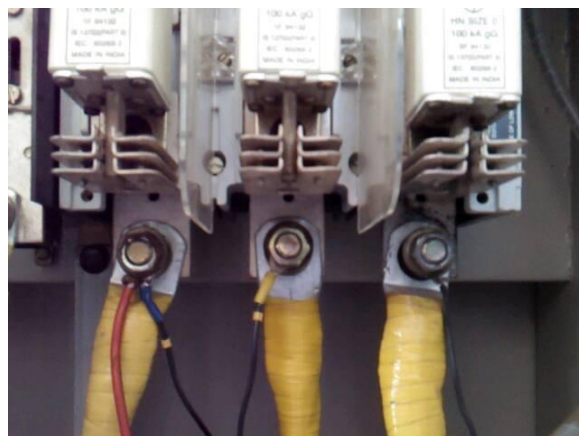
**Thermography Image on Fiber Screener Incoming Point (R-Phase Incoming)**

| Problem Observed | Excessive temperature rise in R-Phase Incoming |
| Cause for the Problem | Loose connection |
| Effect of the Problem | Melting due to high temperature and supply interruption |
| Down Time | 1 hour (minimum) production loss |

| Recommendation | <ul style="list-style-type: none"> <li>• Problem must be quickly addressed during monthly maintenance time</li> </ul> |

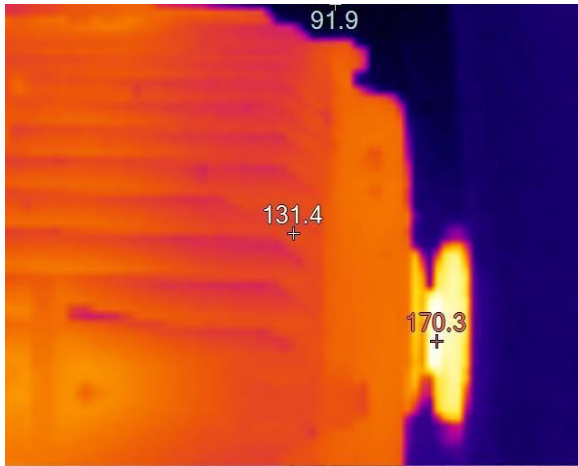
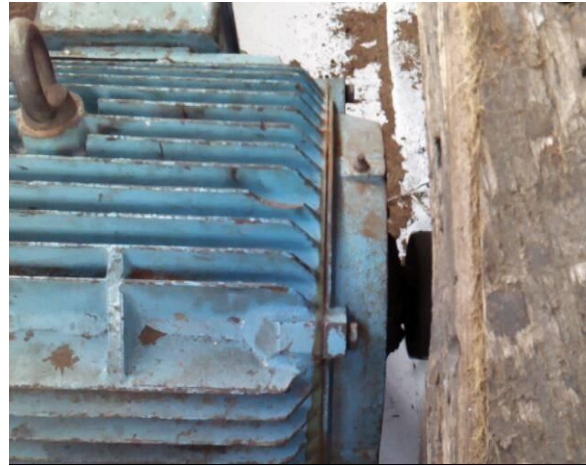
**Thermography Image on Decorticator I (Fiber Screener-Polishing Motor)**

| Problem Observed | Excessive temperature rise in front cover/bearing |
| Cause for the Problem | Bearing weakness/High belt tension/Tightness in front cover |
| Effect of the Problem | Bearing failure |
| Down Time | 1 hour (minimum) production loss |

| Recommendation | <ul style="list-style-type: none"> <li>• Check the belt tension</li> <li>• Oil/creasing in the contact points</li> </ul> |

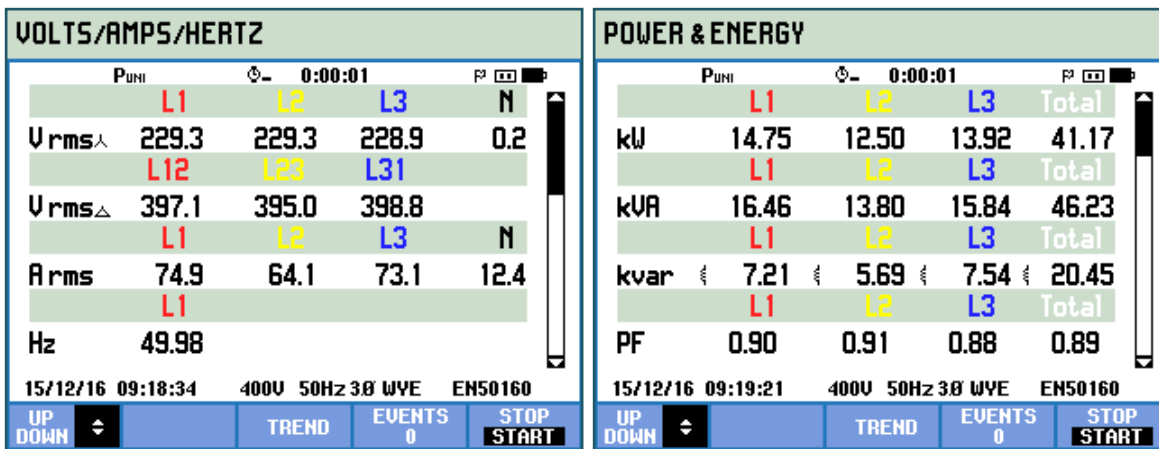
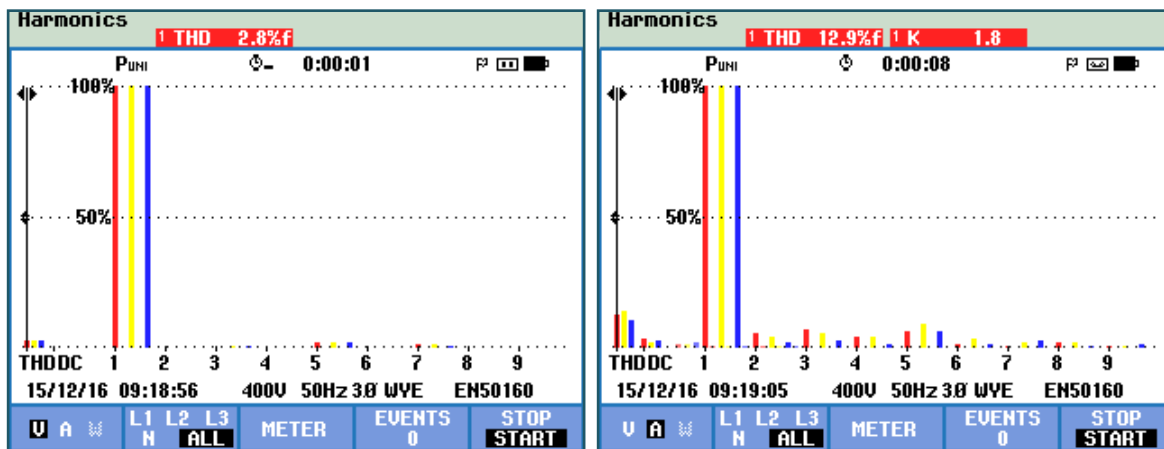
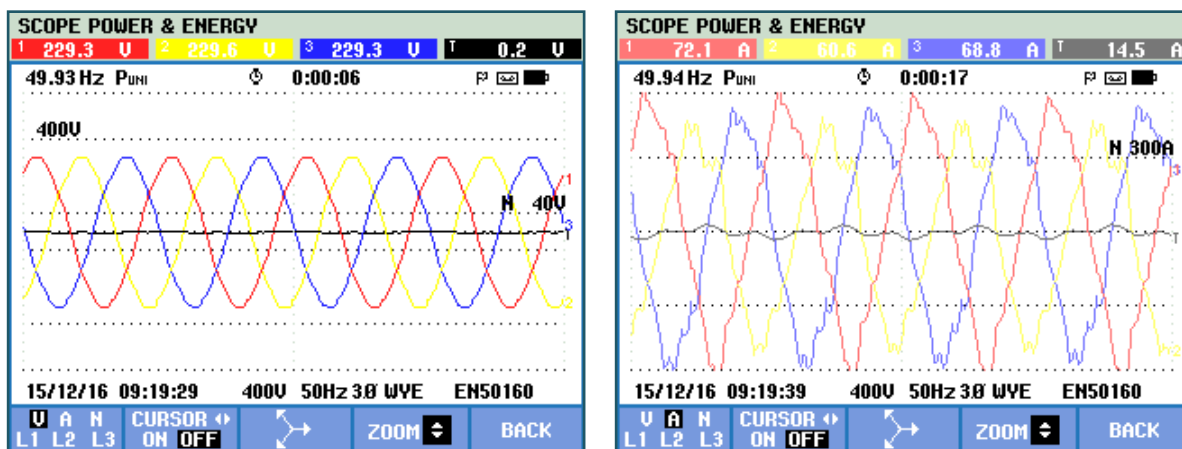
**Voltage/Current/Frequency & Power/Energy-Screen Shots recorded in Main Incoming Panel**

THD<sub>V</sub> & THD<sub>I</sub> -Screen Shots recorded in Main Incoming Panel

Voltage and Current Waveforms -Screen Shots recorded in Main

| Problems Observed | <ul style="list-style-type: none"> <li>Unbalance in three phase circuit</li> <li>Higher value of Total Harmonic Distortion (THD) in current waveform</li> <li>Moderate power factor</li> </ul> |
| Causes for the Problem | From the observation, R phase is heavily loaded followed by Y-phase and B-Phase. This is due to unequal distribution of large single phase loads. |
| | From the observation the value of current THDi is about 17.2 % as against 8 % recommended by the CEA. Higher value of THDi is mainly due to Electronic chokes, Stabilizers, UPS, Inverter and Servo stabilizers not having input filter chokes. |

| | Even though the APFC connected at the input side, the power factor at the time of above measurement is only 0.85. This may due to a) severe unbalance in the circuit , b) capacitor tuning in APFC is not adequate and c) single CT APFC functioning. |
| Effects of the Problem | <ul style="list-style-type: none"> <li>• High neutral current.</li> <li>• Equipment heating and reduction of their life</li> <li>• Higher energy consumption and increased kVA demand</li> </ul> |

| Recommendations | <ul style="list-style-type: none"> <li>• Strongly recommended to distribute the single phase loads equally</li> <li>• Provide active or passive filters in the input side (In consultation with the manufacturers)</li> <li>• Turning the APFC with maximum power factor of 1.00 and check their PF calculation method.</li> </ul> |

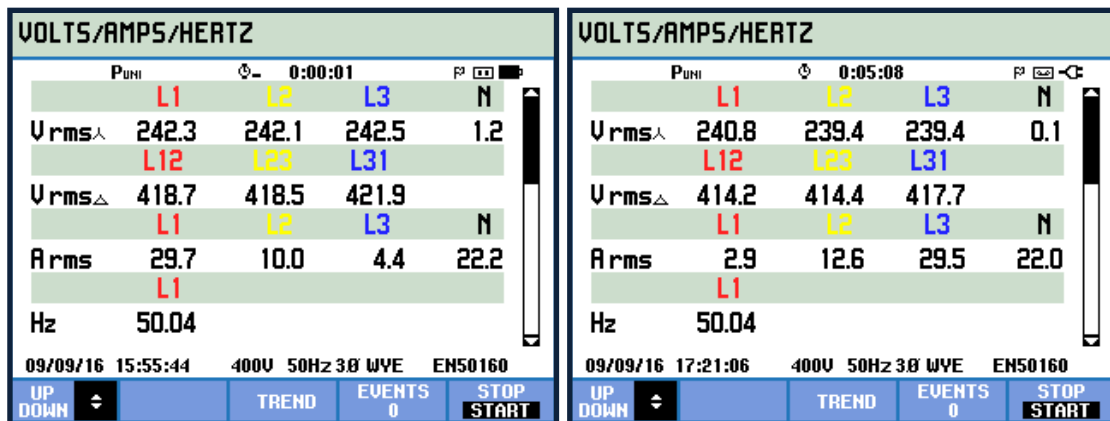
**A. Phase Change:** It is observed with R phase and B phase from the incoming side to the main panel board is interchanged. That is from the incoming side (near to TNEB point) R-Y-B is the sequence where as in the main panel board it is B-Y-R. It should be checked in all the points.

R and B phases are interchanged in main incoming side to main panel board

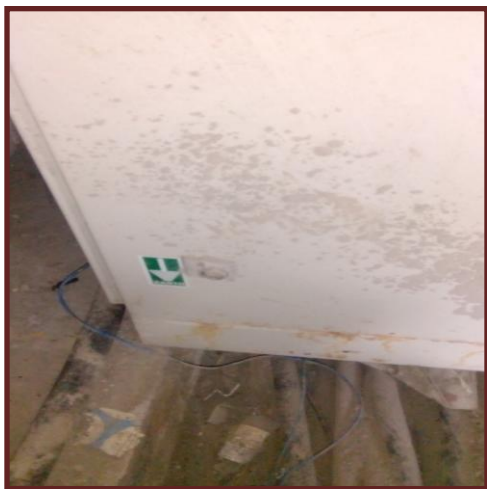
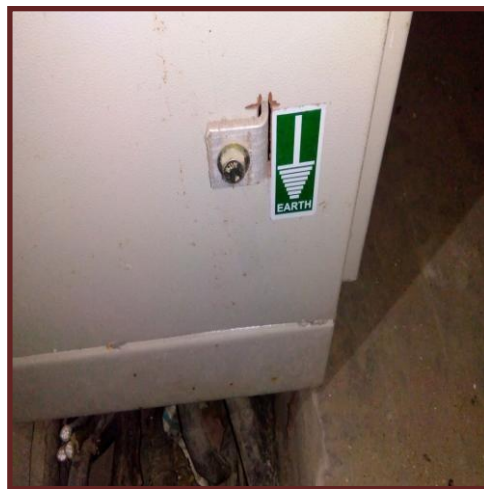
**B. Need for proper earthing:** The overall observation from the complete walk through process of the plant is, many places require proper earthing connection. Even the main incoming panel board does not have the earthing in either side. The important places are shown in Fig. as follows.

**No earthing connection in the main panel board**

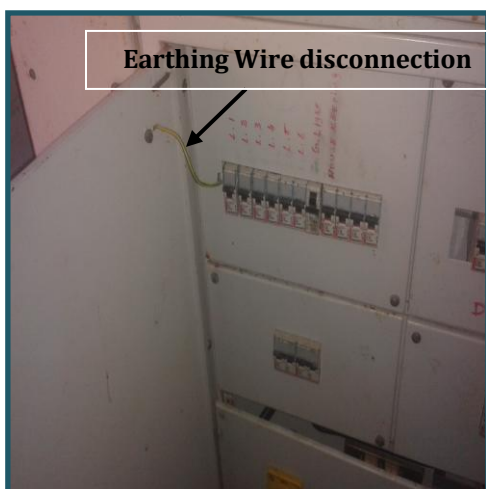
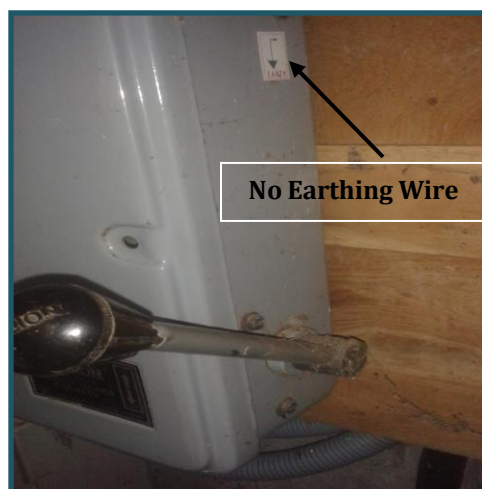
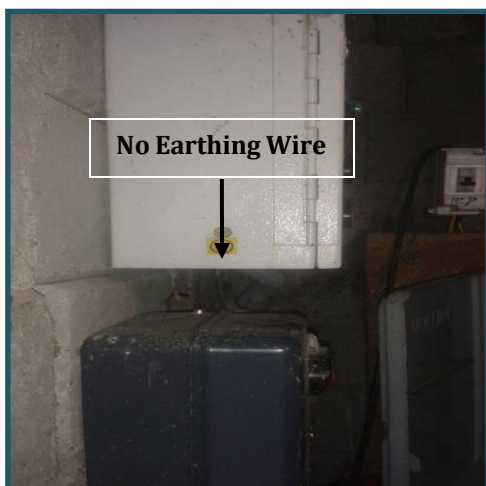
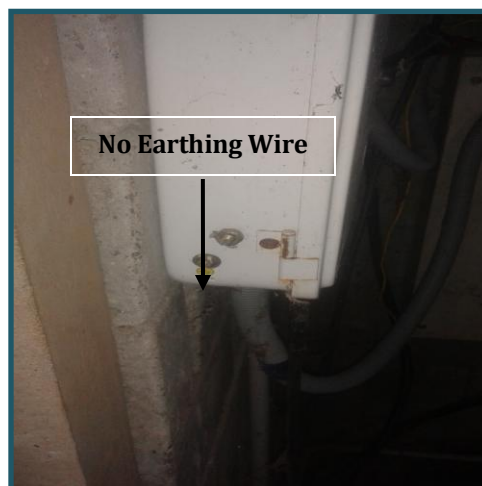
**Improper/No earthing connection in other distribution/panel board**

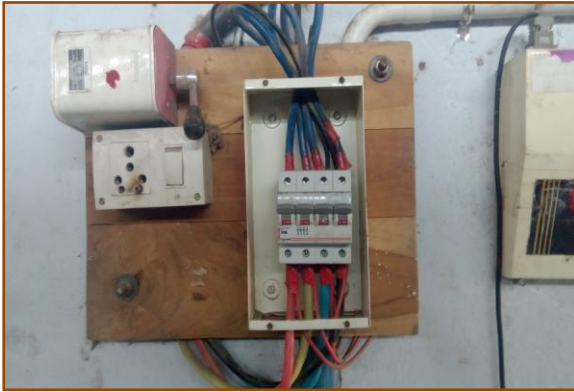
- Multiple connections in single MCB
- Injection Molding machine and lighting loads are connected in same MCB
- Lighting interferences may affect the electric motors/electronic circuits in the

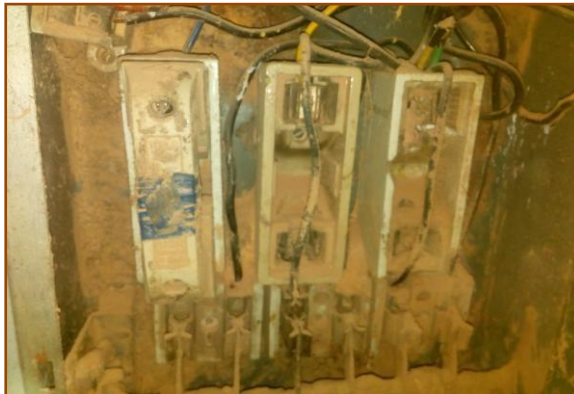
- No fuse link in two phase and is directly connected
- During faulty condition, one phase will be isolated
- This may lead to uneven voltage applied to the machine/system

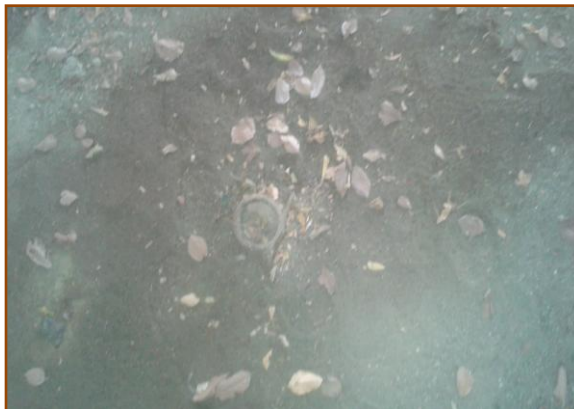
- Earth pit located near to the generator is not maintained properly.
- One more earth pit is also available in the same locality with same condition.

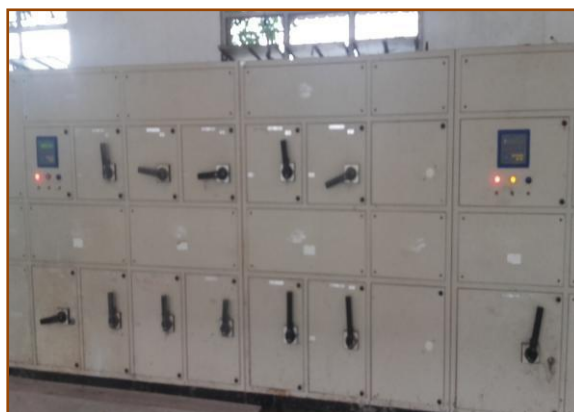
- Incoming panel board does not have the load details. It is recommended to paste the appropriate stickers in each DB switch.
- Also paste DANGER symbol with high voltage indication.

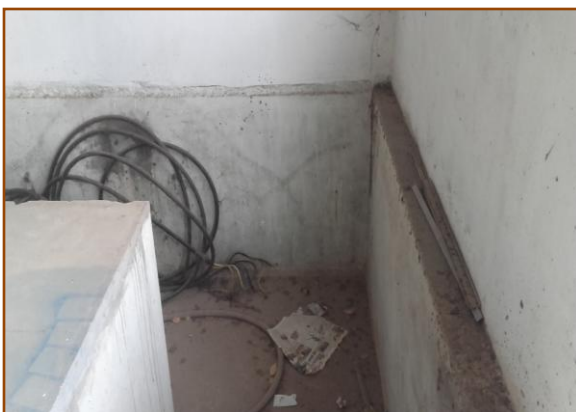
- The cable trench must be closed. Provide sufficient spacing for inlet and outlet points.
- Provide adequate ventilation in the cable trench for temperature evacuation.

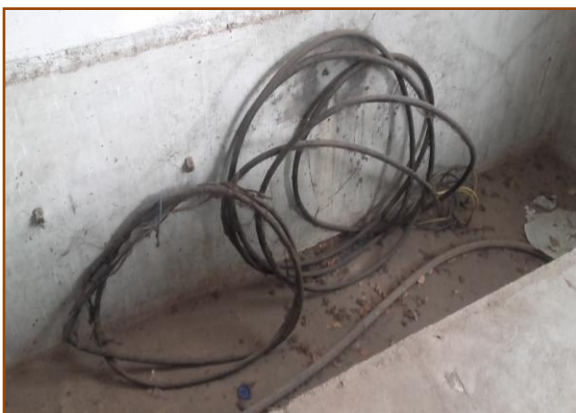
- Loosely rooted electric wires/cables/telecommunication cable
- Recommended to root the cable through cable ducts
